# Inspection Report

## Inspection Report For Happy Home Owner

**Property Address:**  
123 N. 456 W.  
Pleasant Ville Utah 84000

**Vinson Inspection Services, Inc.**

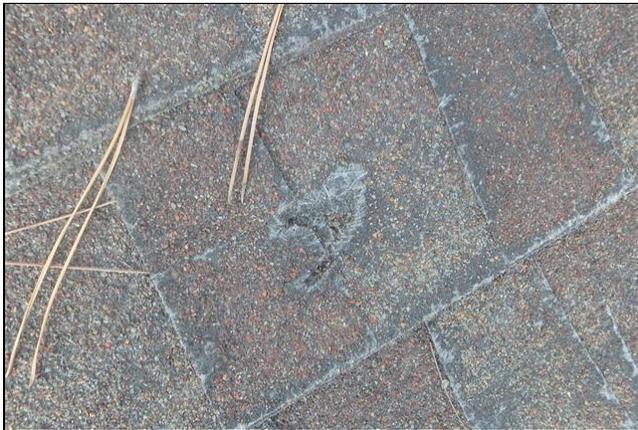
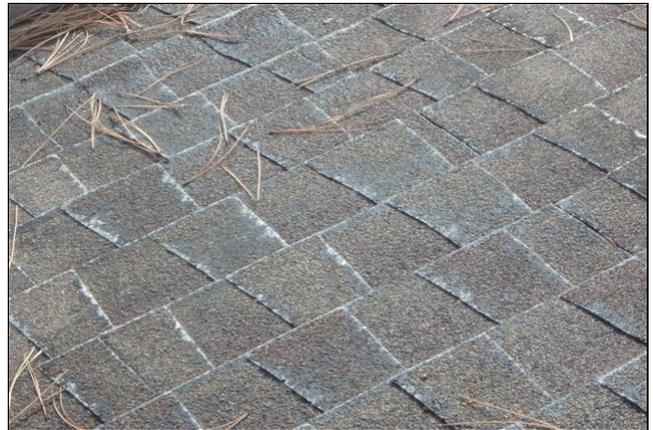
**Major Concern:** The asphalt composition shingles covering the roof of this home had severe deterioration visible throughout the roof and are at the end of their long-term service life. You should consult with a qualified roofing contractor before the expiration of your Inspection Due Diligence Deadline to discuss options and costs for replacement.

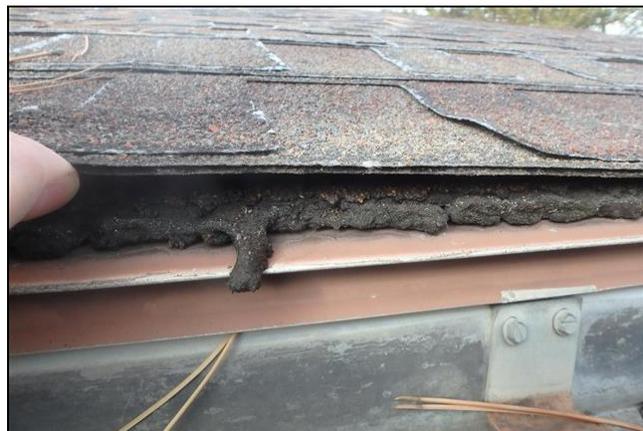
1.0 Item 3(Picture)

**FYI:** The roof had two existing layers of composition asphalt shingles installed at the time of the inspection. Two is the maximum allowed. This condition will result in the following:

- Reduced asphalt shingle lifespan compared to similar shingles installed over a proper substrate.
- When new roofing is required, all two layers will need to be removed before new roofing material can be installed. This is much more expensive than simply adding another layer and you may wish to take this into account in your consideration of this property.

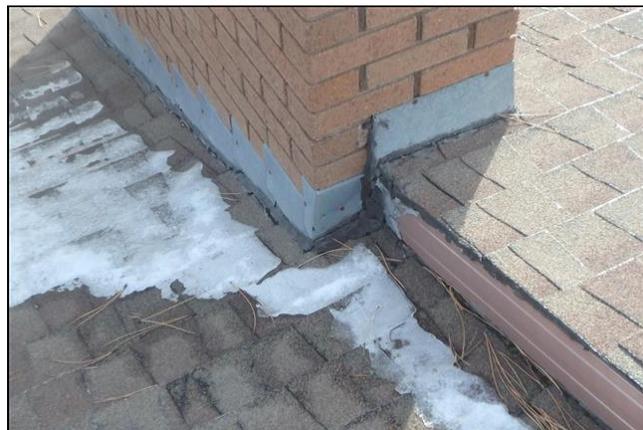
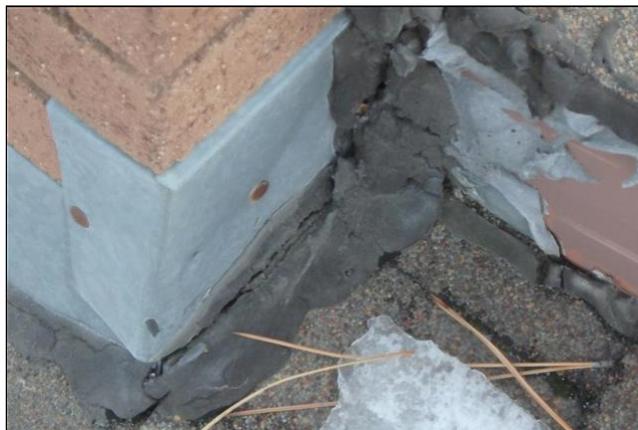
**Major Concern:** The flashing around chimney was installed incorrectly and is reliant upon a sealant to help prevent moisture intrusion. Evidence of leakage into the garage was noted at the time of the inspection. The inspector recommends replacement of the flashing by a qualified roofing contractor.

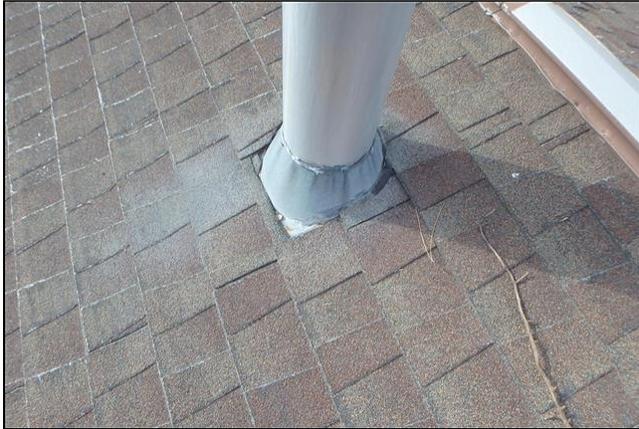
1.1 Item 3(Picture)

**Improve:** The flashing around all roof penetrations has been installed incorrectly and should be replaced. New vent flashing should be installed to help prevent moisture from entering into the roof system. The inspector recommends correction by a qualified roofing contractor.

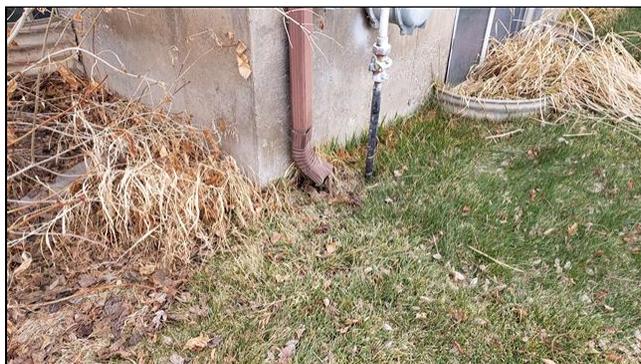
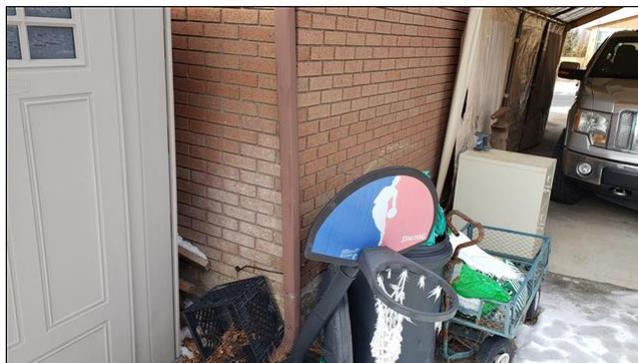
**Improve:** One or more downspouts on the exterior of the home are damaged and should be repaired or replaced to prevent possible failure and to allow for proper drainage away from the foundation.

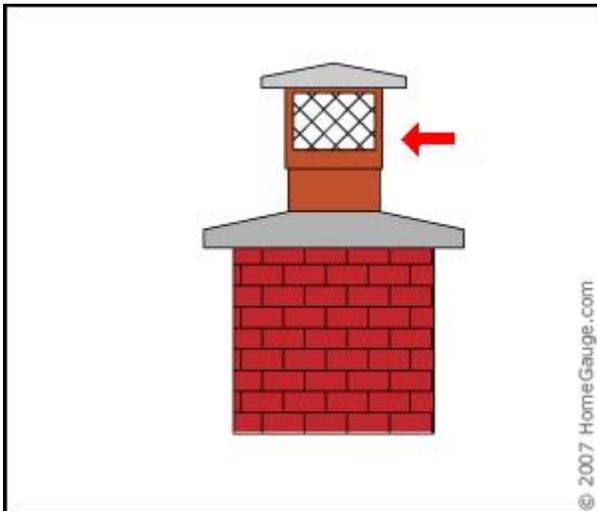
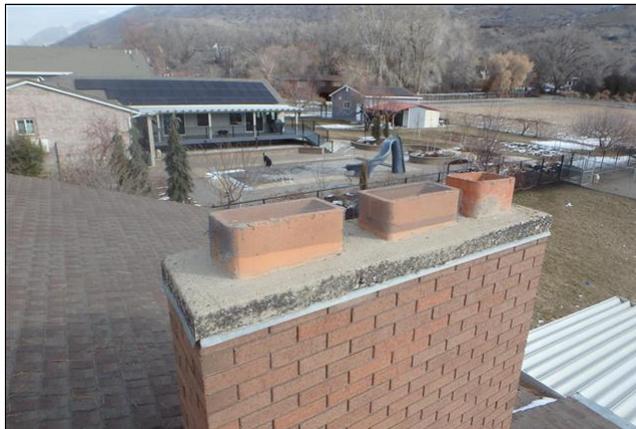
**Improve:** A rain cap and vermin screen should be installed on the masonry chimney.

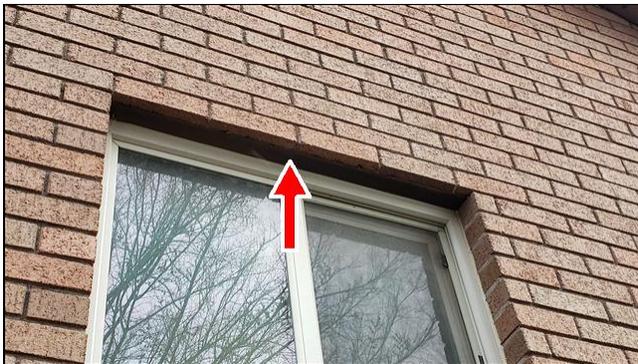
2.0 Item 1(Picture)

**Improve:** The lentils are rusting. Lentils are metal beams that support the brickwork above openings in a wall (window/doors). The inspector recommends sanding and apply a rust preventative paint to help preserve the remaining life.

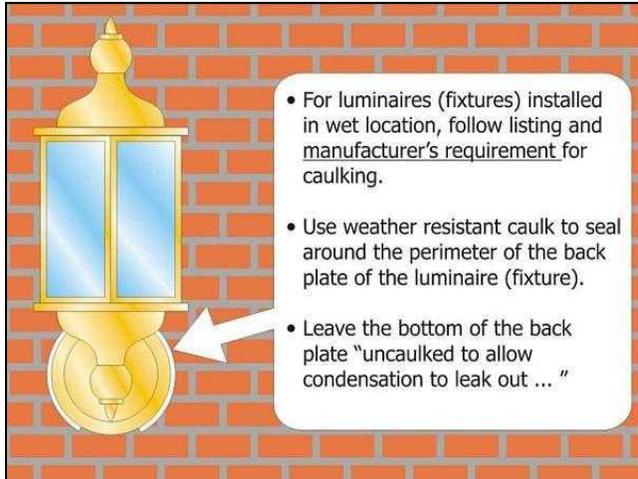
2.0 Item 2(Picture)

**Improve:** The areas around exterior light fixtures have not been sealed. Recommend caulking around fixtures with appropriate sealant to help prevent moisture intrusion in the wall assembly.

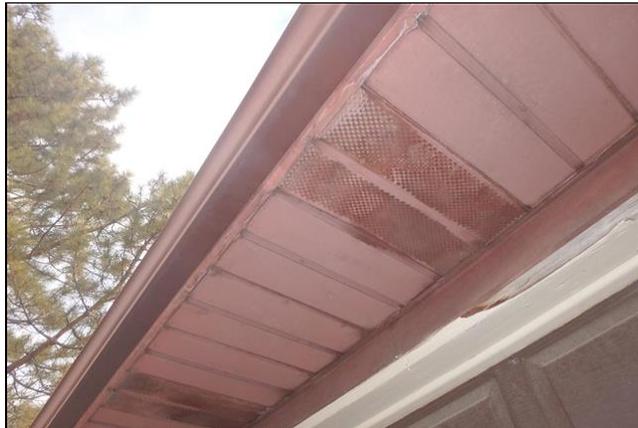
2.1 Item 1(Picture)

**Monitor:** Water staining to soffit vents was observed. This is a sign of a possible roof leak and should be monitored.

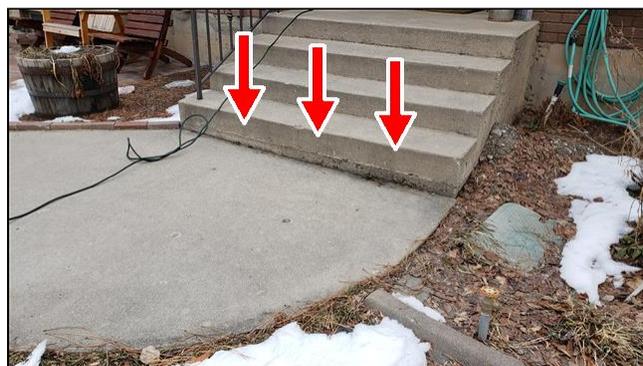
2.3 Item 1(Picture)

**Safety Issue:** The risers at this stairway exceeded 7 3/4 inches in height. This condition is considered a potential trip/fall hazard. Consider replacing the steps with one in which the riser heights adhere to the generally-accepted current standards of 4 inches minimum and 7 3/4 inches maximum height.

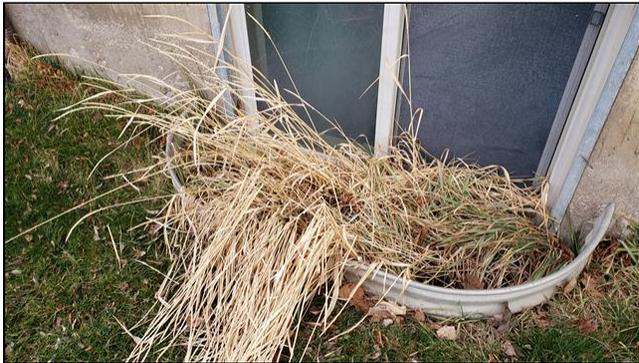
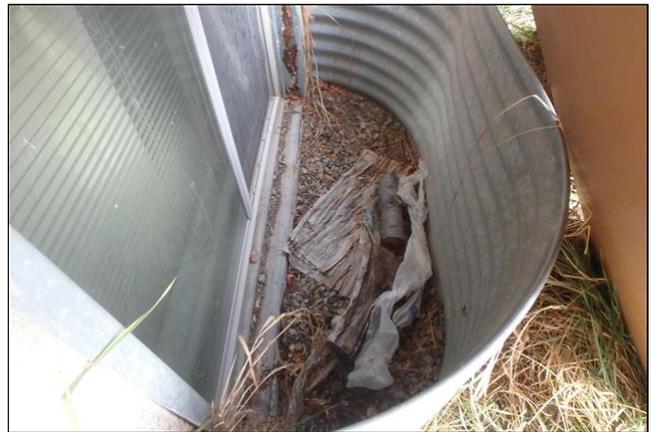
**Improve:** The window wells had accumulated debris; this can allow moisture intrusion into the basement. The window wells should be cleared to encourage proper drainage and minimize the retaining of moisture near the foundation and window.

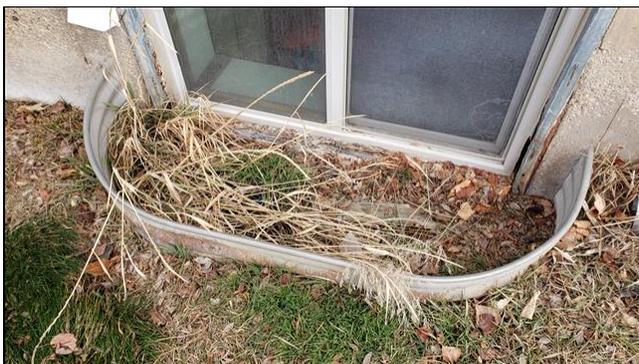
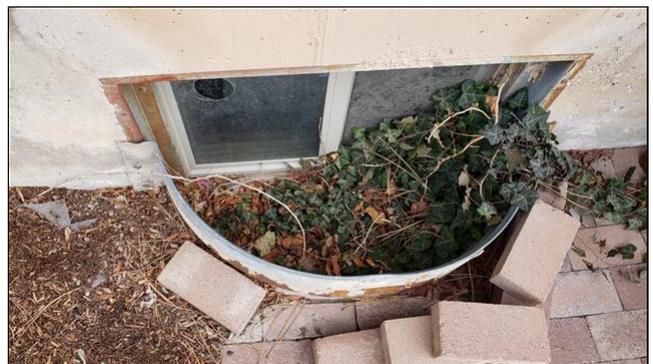
**Improve:** The basement window wells do not have the proper drainage needed to help prevent the retaining of moisture near the foundation and window. It is recommended that 4"-6" inches from the window sill to the ground be provided to ensure the proper drainage.

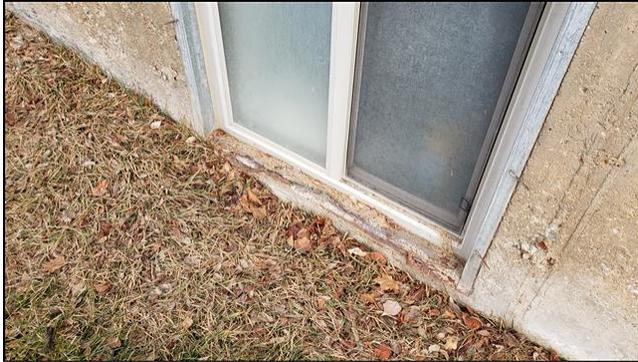
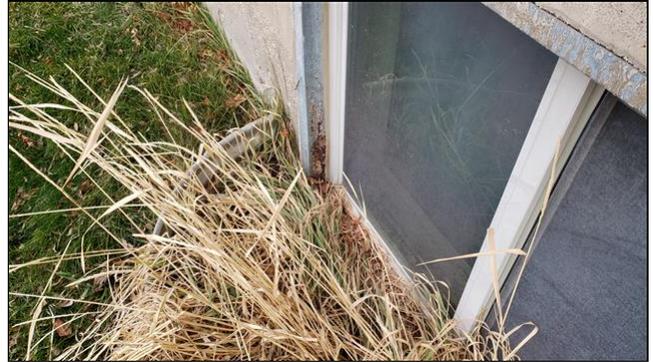
**Improve:** The exterior basement window frames are severely rusting and will require extensive repair or replacement in order to help prevent moisture intrusion into the basement.

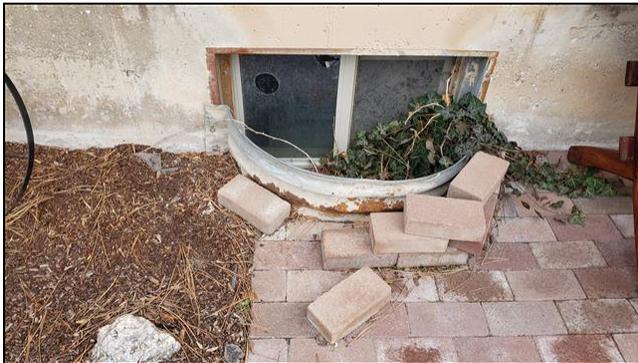
2.4 Item 9(Picture)

**Improve:** The basement bathroom window well is rusting. Repairs in the short term may extend the life of the well, however, replacement will likely be required in the future.

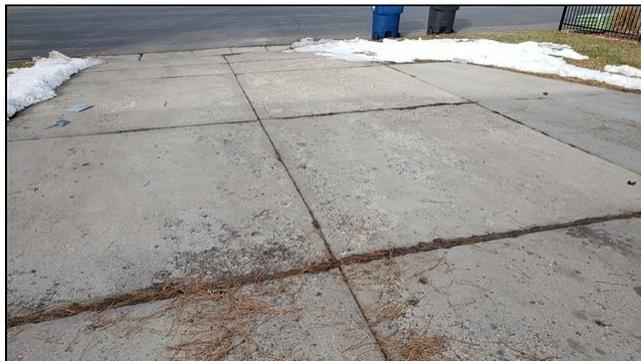
2.5 Item 1(Picture)

**Improve:** Significant spalling was visible on the surfaces of the concrete driveway. Spalling is surface deterioration which causes large flakes of concrete to detach from the surface. It can be caused by poor concrete mix at the time of original construction made worse by freeze damage or by salt or other chemicals used for de-icing purposes and made worse by freeze damage. It is recommended that the concrete be resurfaced by a qualified contractor to prevent additional damage.

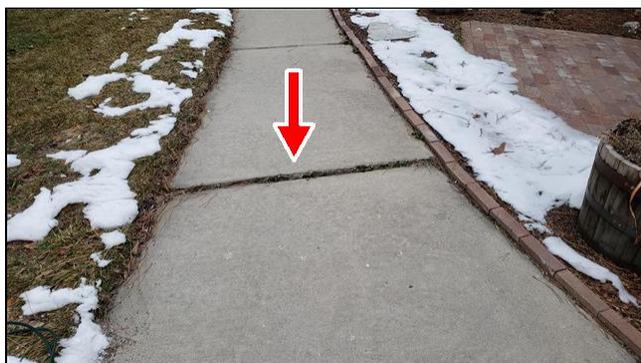
2.6 Item 1(Picture)

**Safety Issue:** Unevenness due to settling and/or heaving was observed in the concrete of the walkway and is considered a trip hazard. Cracks and/or joints should be filled with an appropriate sealant to help prevent moisture from entering and causing further settling. Replacement or lifting (jacking) the concrete may be necessary to correct unevenness in concrete. Repair by a qualified contractor is recommended.

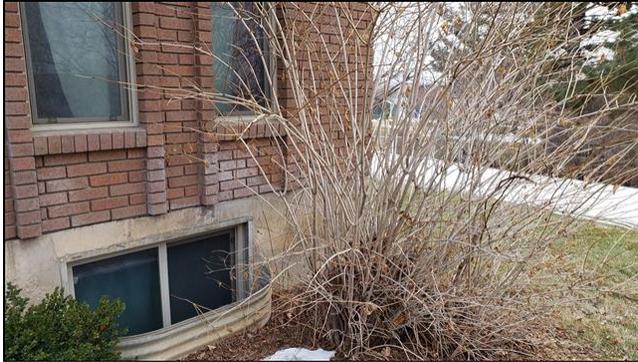
2.7 Item 1(Picture)

**Improve:** The bush at the front of the home should be removed to prevent damage to exterior wall covering, windows, and gutters.

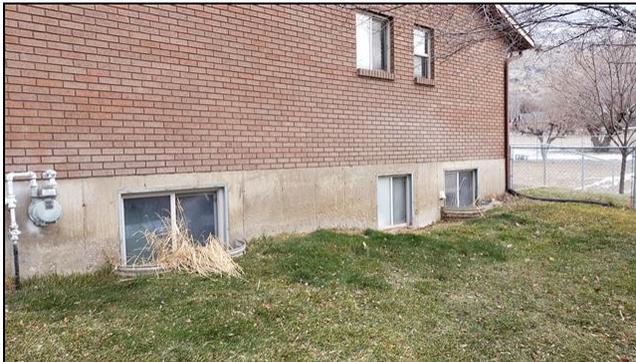
2.8 Item 1(Picture)

**Major Concern:** The grading needs improvement. There is a negative slope at various areas around the home which can cause or contribute to water intrusion into the basement. I recommend correcting landscape to drain water away from home. This can usually be accomplished by the addition of top soil. The ground should slope away from the house at a rate of one inch per foot for at least the first ten feet. Ideally, at least eight (8) inches of clearance should be maintained between soil level and the top of the foundation walls.

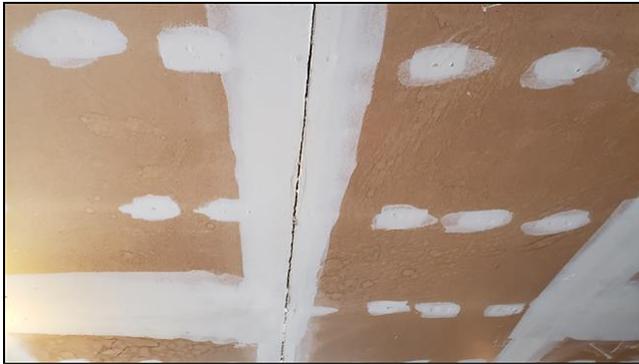
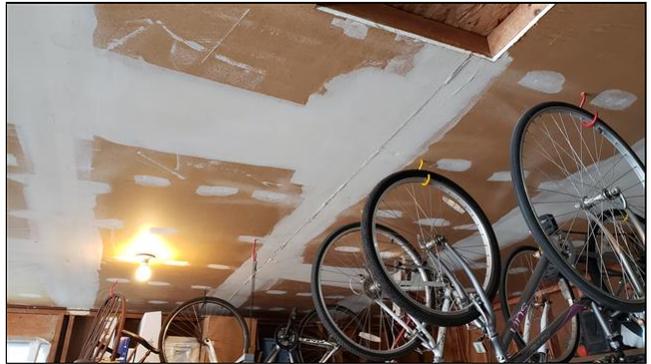
**Improve:** Larger than typical cracking in the garage ceiling was noted. It is recommended you consulting with a qualified contractor to assess this condition and to discuss options and costs for repairs.

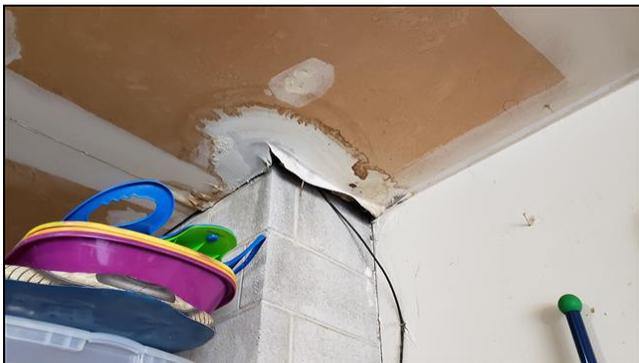
3.3 Item 3(Picture)

**Monitor:** Water damage to the garage ceiling was observed. Although no moisture was detected at the time of the inspection, this area should be monitored.

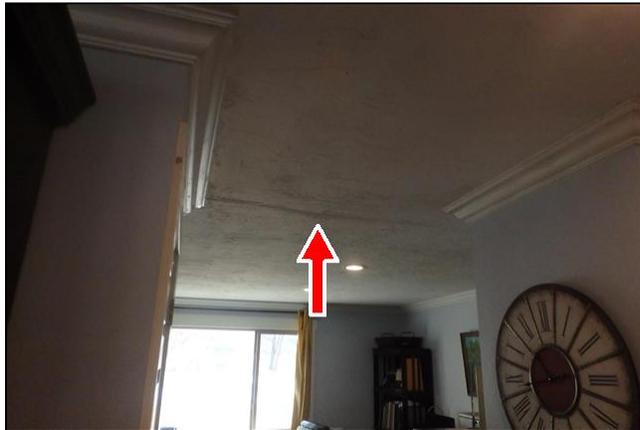
4.0 Item 1(Picture)

**Major Concern:** Ceiling cracks were noted between the kitchen and living room and also between the hallway and living room. This may be the result of the removing a wall. Recommend asking the current owner if a wall has been removed during remodeling. If so, verify the work was done by a qualified contractor and sufficient support added in place of the wall. If a qualified contractor was not used, recommend having a contractor or structural engineer evaluate.

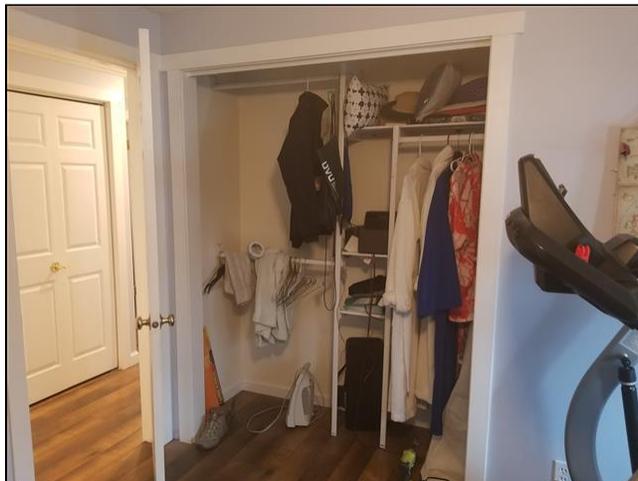
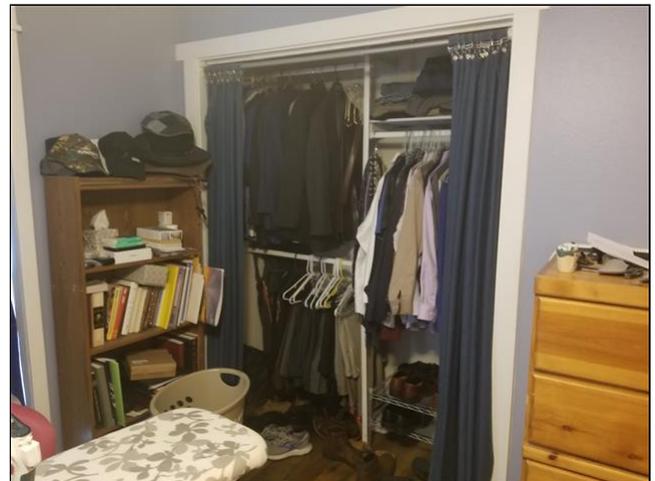
**Improve:** The 1st and 2nd bedroom closet doors are missing and should be replaced as needed.

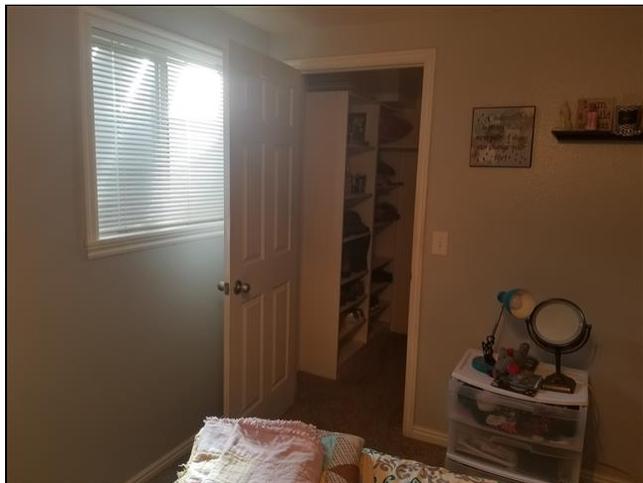
4.2 Item 3(Picture)

**Improve:** The 1st basement bedroom door does not latch closed. Repairs should be made as needed.

**Improve:** The 1st basement bedroom closet door does not latch closed. Repairs should be made as needed.

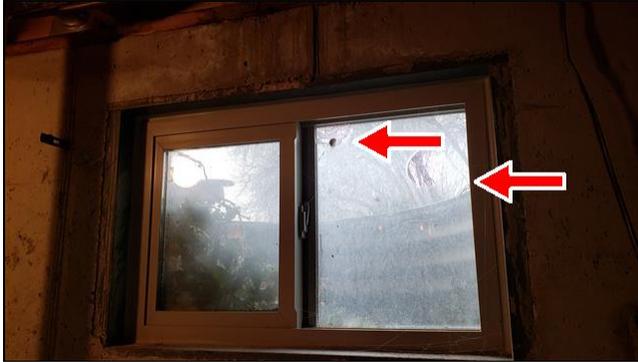
**Major Concern:** The windows in the laundry/storage room and small side room are broken. The windows should be replaced to prevent injury or damage.

4.3 Item 1(Picture) Basement laundry room

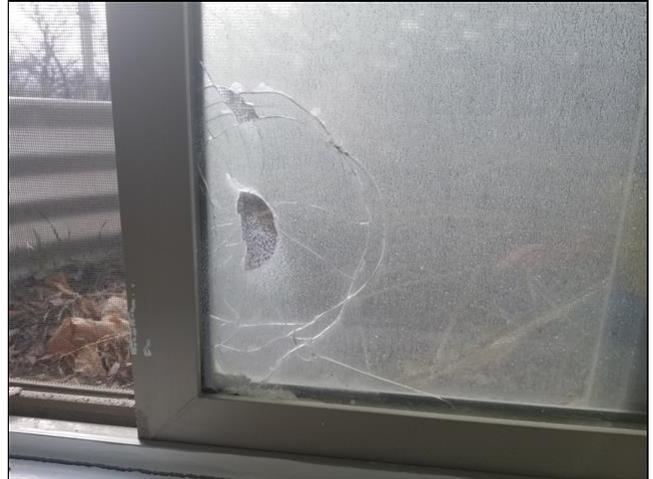
4.3 Item 2(Picture) Basement side room

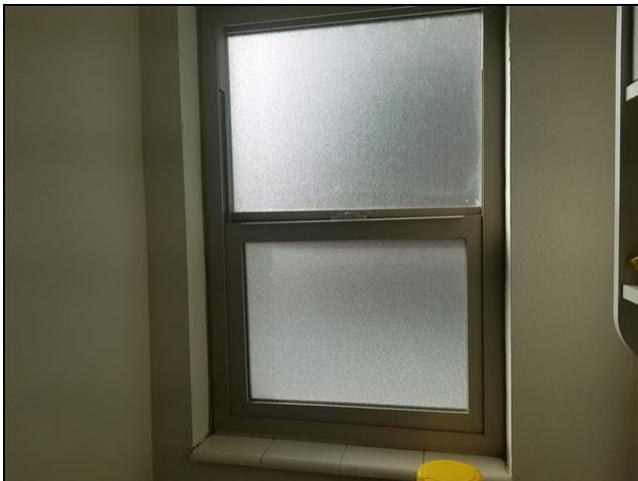
4.3 Item 3(Picture)

**Improve:** The window in the master bathroom does not open or close properly. Hardware improvements should be made to ensure proper function.

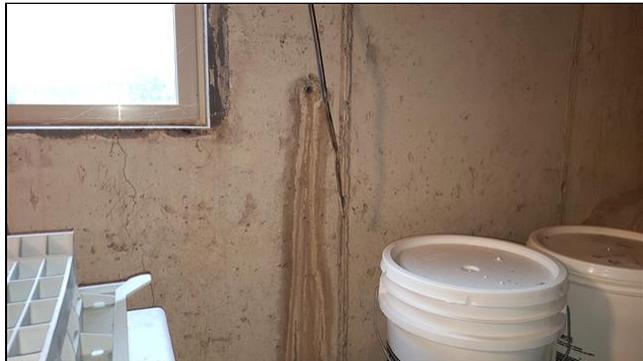
4.8 Item 1(Picture)

**Monitor:** Evidence of moisture intrusion into the basement was observed. It should be understood that it is impossible to predict the severity or frequency of moisture penetration on a one time visit to a home. The ground around the house should be sloped to encourage water to flow away from the foundations. Gutters and downspouts should act to collect roof water and drain the water at least five (5) feet from the foundation. Downspouts that are clogged or broken below grade level, or that discharge too close to the foundation, are the most common source of basement leakage.

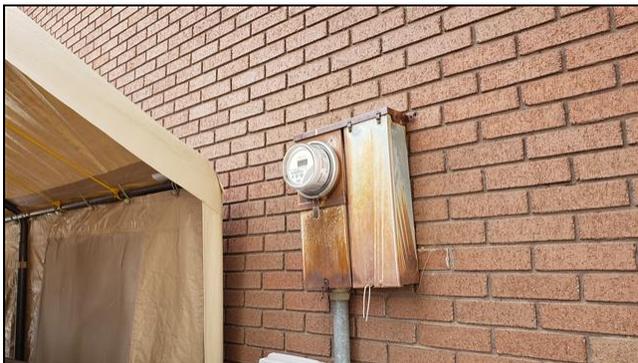
5.0 Item 1(Picture)

**Improve:** The service box shows evidence of rusting, suggesting the presence of moisture. An electrician should be consulted to replace the service panel.

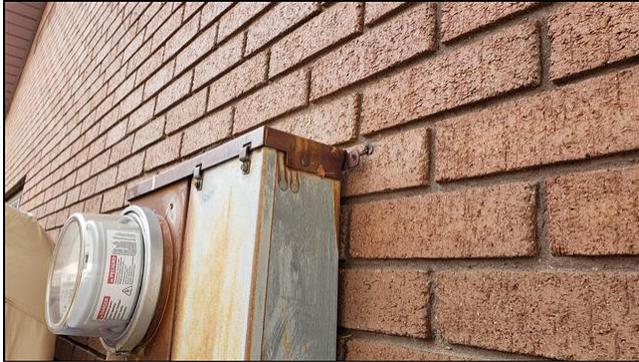
5.0 Item 2(Picture)

**Improve:** The wall anchor securing the exterior panel is loose/damaged and should be replaced by a qualified electrical contractor.

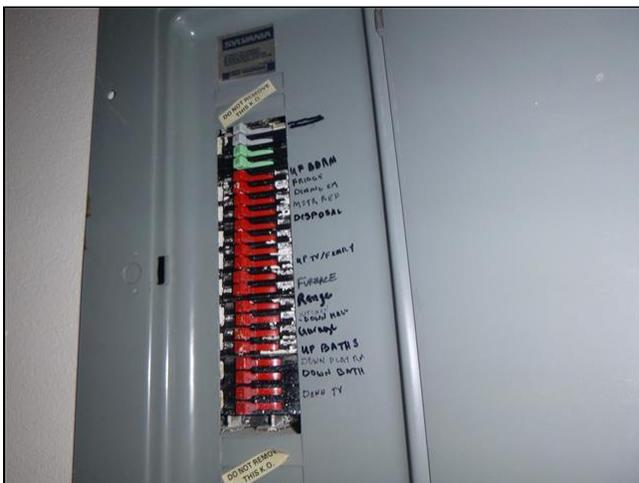
5.1 Item 1(Picture)

**Monitor:** The main electrical service panel was made by Sylvania. Sylvania service panels are reputed to have a high rate of circuit breaker failure which can result in a fire or shock/electrocution. The inspector recommends that you consult with a qualified electrical contractor concerning the necessity for replacing this service panel.

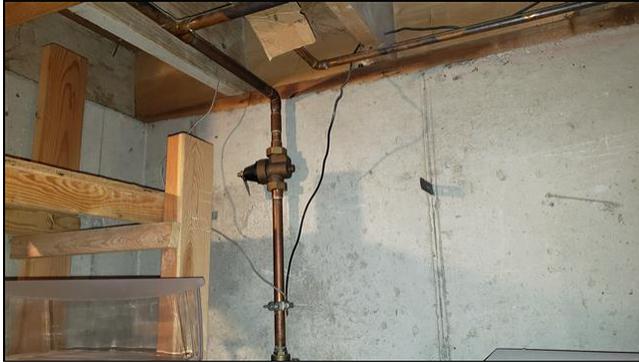
5.1 Item 3(Picture)

**Improve:** The main electrical service has not been properly grounded to the main water supply pipe. Consider consulting with a qualified electrical contractor to ensure that the electrical service is adequately grounded.

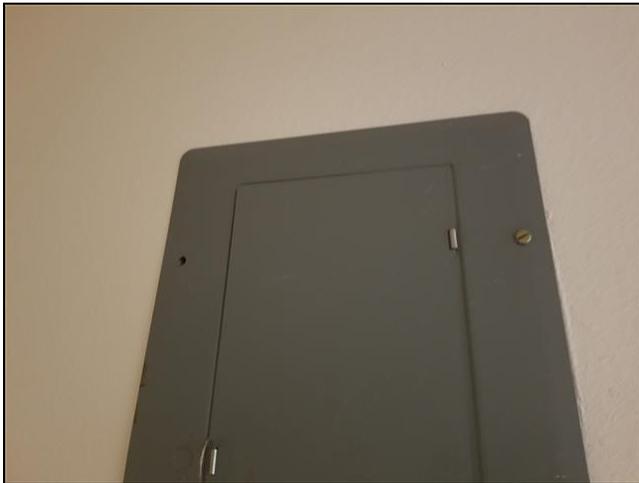
5.1 Item 4(Picture)

**Improve:** The dead front cover of the main electrical panel was missing screws at the time of the inspection. The inspector recommends that appropriate screws be installed to securely attach the dead front cover.

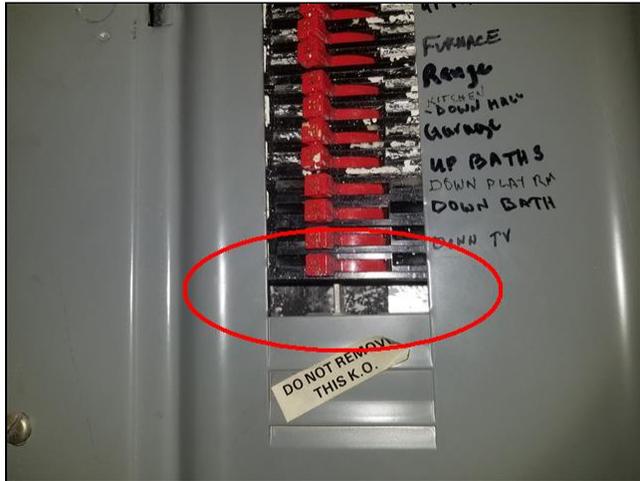
5.1 Item 5(Picture)

**Safety Issue:** A gap in the dead front cover of the main panel where a circuit breaker is missing may allow a person to come into contact with energized electrical components. This potential shock/electrocution hazard should be corrected by a qualified electrical contractor.

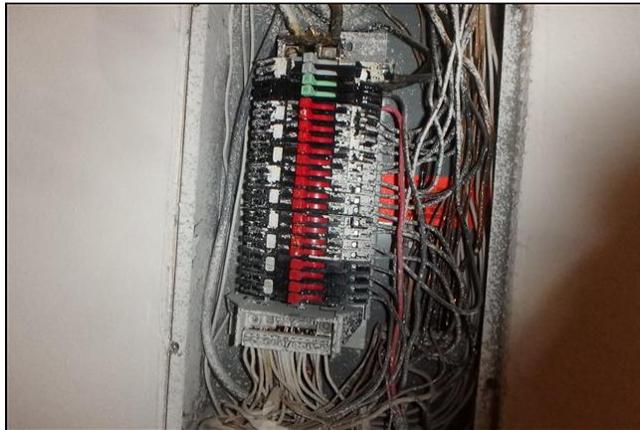
5.1 Item 6(Picture)

**Improve:** The interior of the main electrical service panel was contaminated by paint. This condition appeared to be the result of overspray during wall painting. This condition may affect the ability of electrical components within the service panel to function as they were designed. The inspector recommends that an evaluation and any necessary corrections be made by a qualified electrical contractor.

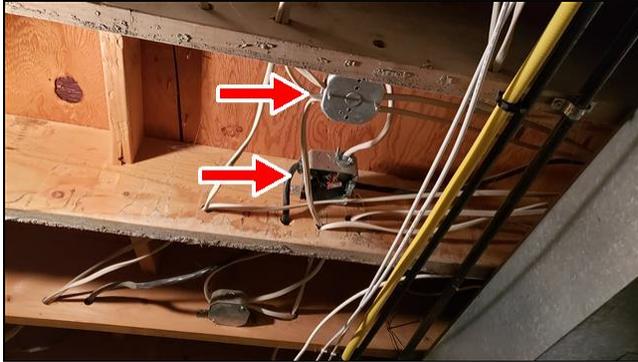
5.2 Item 1(Picture)

**Improve:** A junction box in the storage room is missing a cover plate. An approved cover plate should be installed to protect the wiring.

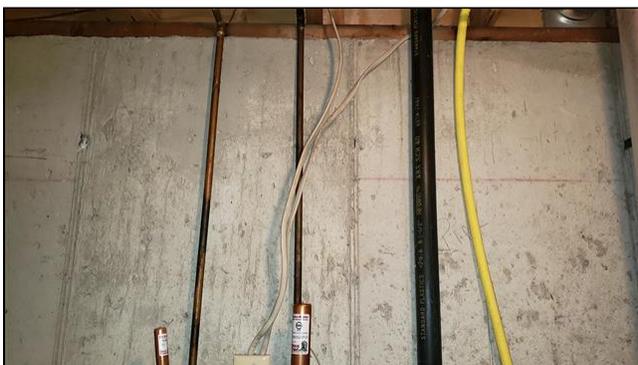
5.2 Item 4(Picture)

**Improve:** Wiring in the laundry/storage room exposed to damage should be installed in conduit.

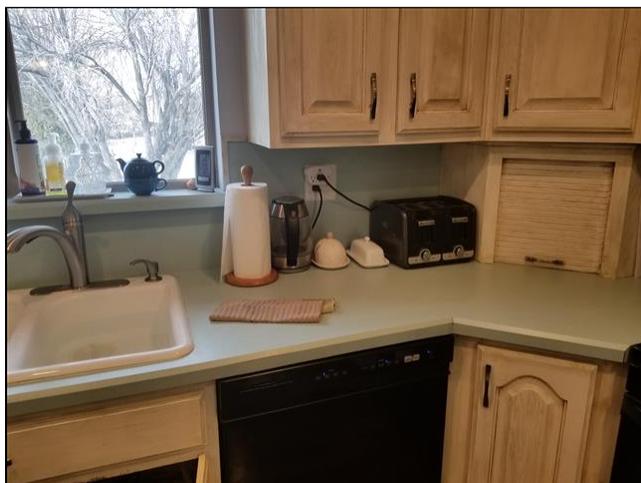
5.3 Item 1(Picture)

**Improve:** An outlet in the kitchen has been wired incorrectly (the hot and neutral wires are reversed). A qualified electrical contractor should evaluate and make necessary repairs.

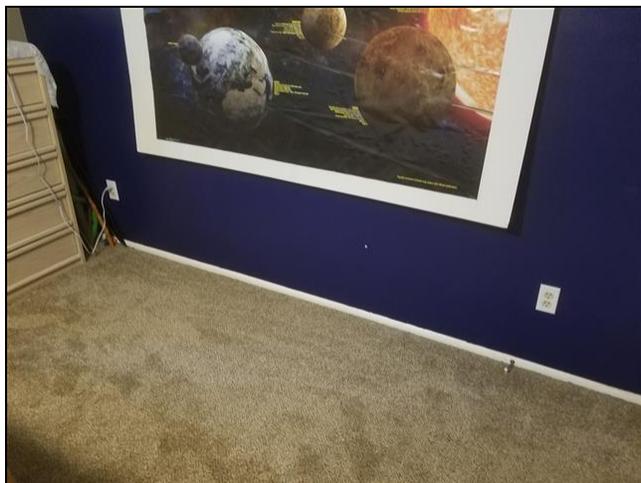
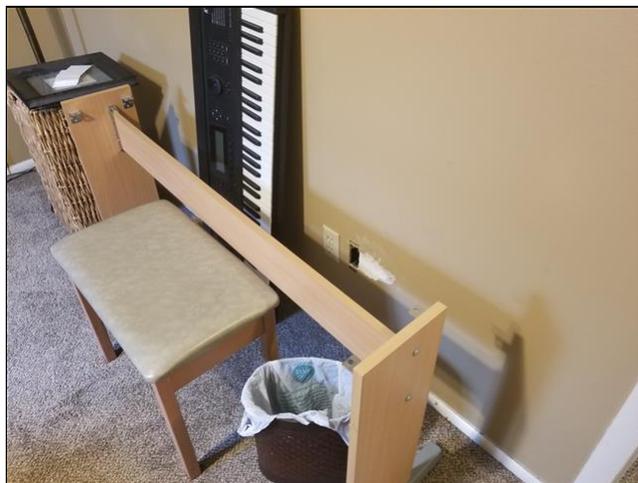
**Improve:** Multiple outlets in the 2nd and 3rd basement bedrooms have been wired incorrectly (the hot and neutral wires are reversed). A qualified electrical contractor should evaluate and make necessary repairs.

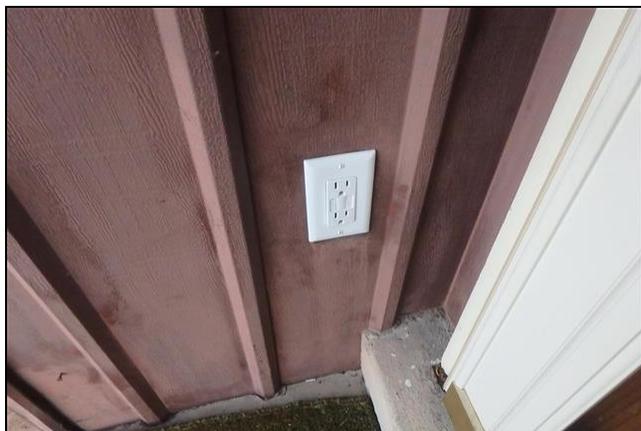
5.3 Item 4(Picture)

**Safety Issue:** The outlet at the front of the home is missing a weatherproof cover. A proper exterior cover should be installed.

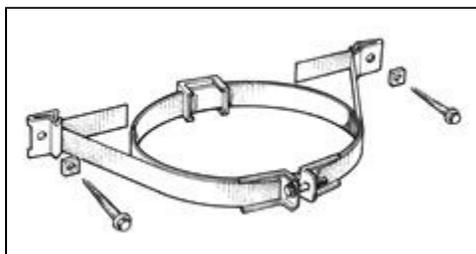
**Improve:** The water heater(s) should be properly anchored or strapped to resist movement during earthquake conditions. Seismic Straps are metal belts that strap the water heater to a wall. The seismic strapping holds the water heater upright in the event of an earthquake. The straps are not intended to protect the plumbing or avoid flooding. Instead they are specifically required to protect the gas lines. The proper way to install the straps is to use two straps. A general rule is to install the straps 9 inches from the top of the tank, and 4 inches above the controls at the bottom of the tank. The straps should be secured to a stud in the wall with a 3-inch lag bolt. Do not use plastic anchors in the drywall. The straps should be looped around the tank. And finally, if the water heater stands more than three inches away from a wall at the back, a supporting brace or block should be used.

6.0 Item 1(Picture) Seismic Strapping

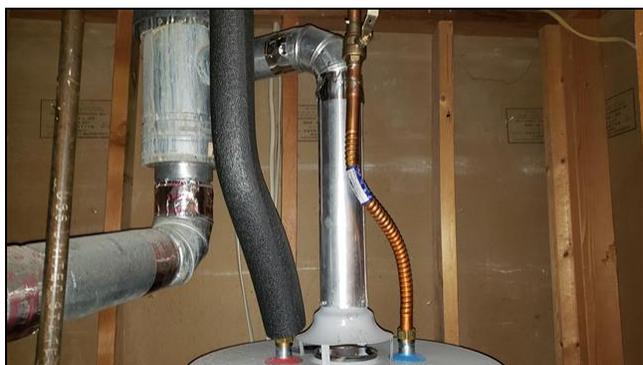
6.1 Item 1(Picture)

**Improve:** The gas-fired water heater has a three-inch diameter exhaust flue. Newer standards require a 4-inch flue. It may be required to upsize the flue when the water heater is replaced.

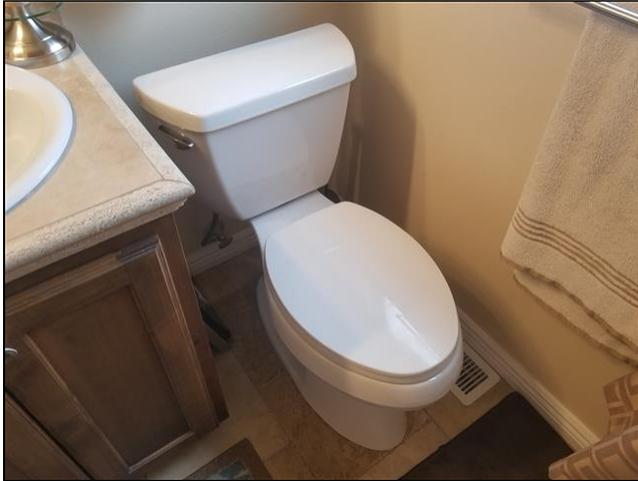
6.3 Item 1(Picture)

**Improve:** The main floor hallway bathroom toilet is loose and should be properly secured. Also, caulking should be applied around the base after the toilet has been secured. Both can help prevent leakage into the floor system.

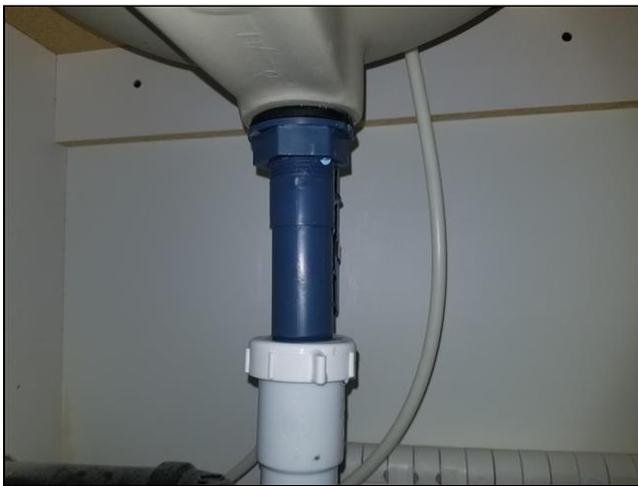
6.3 Item 2(Picture)

**Improve:** A leak was detected in the drain line under the main floor hallway bathroom right sink. Repairs should be made by a qualified plumber.

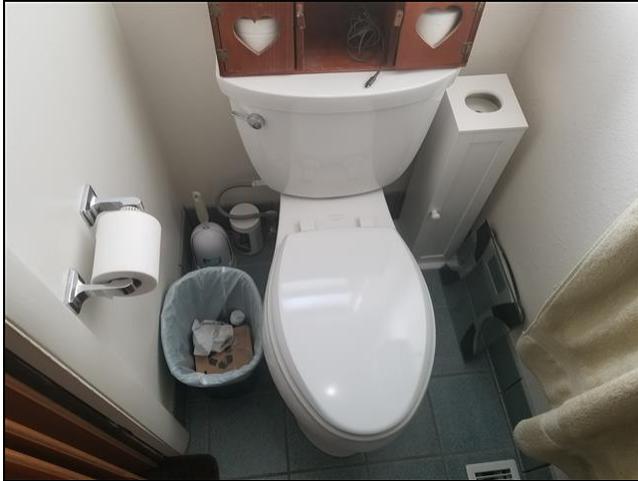
6.3 Item 3(Picture)

**Improve:** The master bathroom toilet is loose and should be properly secured. Also, caulking should be applied around the base after the toilet has been secured. Both can help prevent leakage into the floor system.

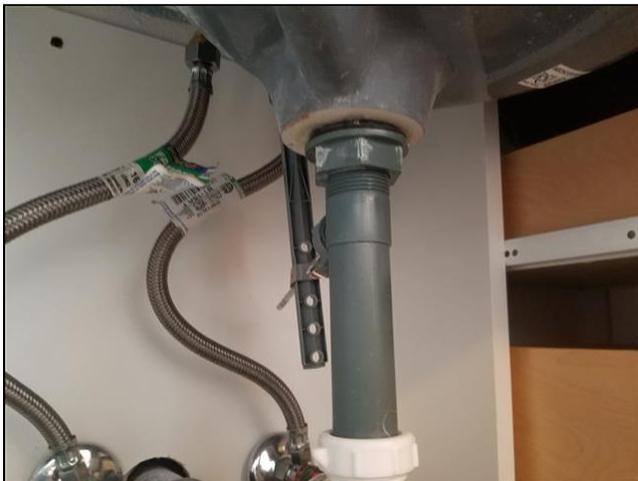
6.3 Item 4(Picture)

**Improve:** A leak was detected in the drain line under the basement bathroom left sink. Repairs should be made by a qualified plumber.

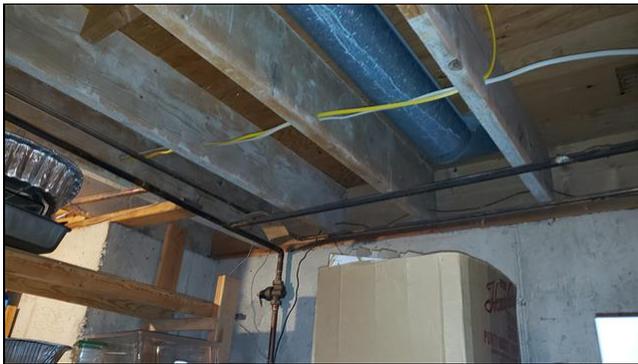
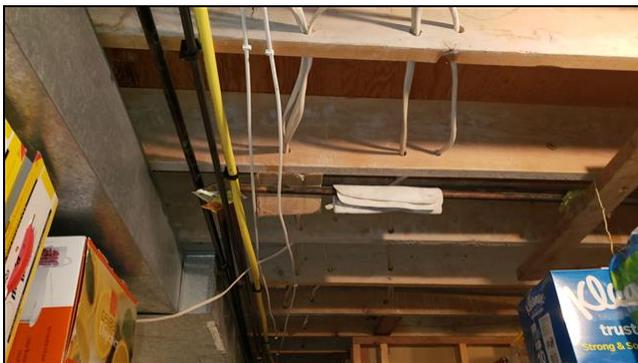
**Improve:** The supply pipes in the storage room lack adequate support. Recommend repair as needed by a qualified plumbing contractor.

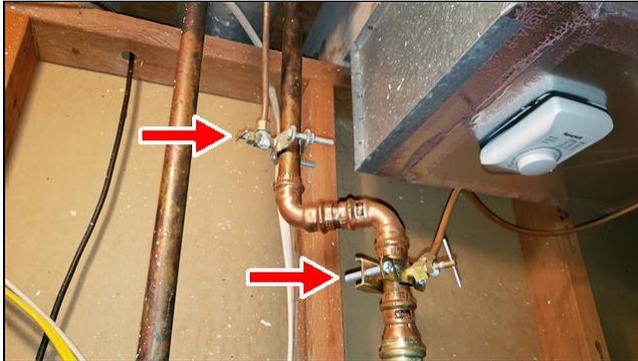
6.4 Item 4(Picture)

**Improve:** Saddle valves have been installed on the the supply pipe located in the basement utility room. This type of valve also known as a piercing saddle valve, saddle tap or needle valve, consists of a clamp that punctures a hole in an existing water intake pipe. It is a shortcut used instead of installing a permanent and secure connection. Because saddle valves are not permanently attached, they are prone to leaks and can potentially cause extensive property damage when they ultimately leak. Recommend having a plumber remove the valve and repair the line and have a proper fitting installed for.

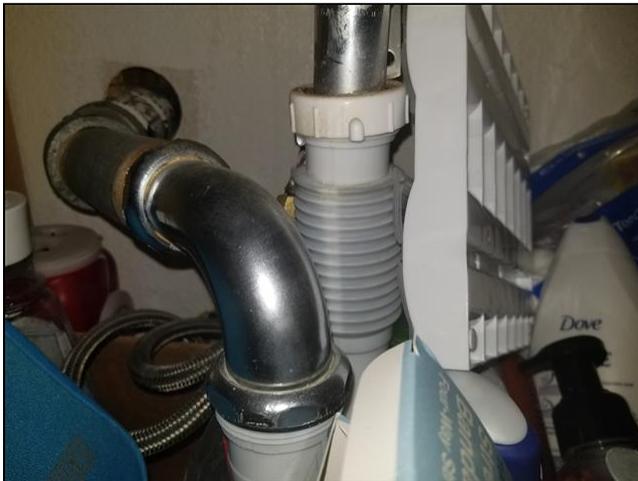
6.5 Item 1(Picture)

**Improve:** The flex piping under the master bathroom sink is an improper material to use for the drain line. This is generally considered to be a temporary fix. Flex piping clogs easier and is less durable. The proper pipe fittings should be used to bring the drain line up to current building standards. Work should be performed by a qualified plumber.

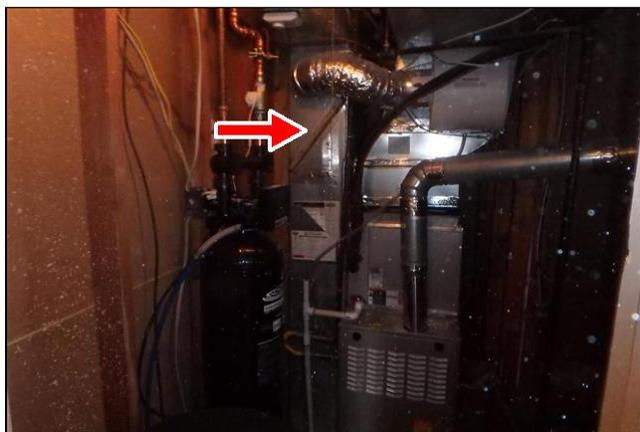
7.0 Item 1(Picture)

**Improve:** The furnace air filter was dirty and should be changed. Filters should be checked every month and replaced as necessary. Failure to change the filter when needed may result in the following problems:
