# Inspection Report

## Inspection Report For Happy Home Owner

**Property Address:**  
123 N. 456 W.  
Pleasant Ville Utah 84000

**Vinson Inspection Services, Inc.**

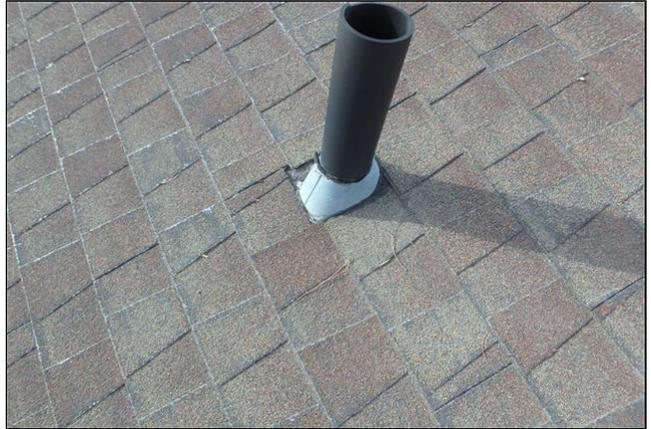
1.1 Item 4(Picture)

**Improve:** The flashing around all roof penetrations has been installed incorrectly and should be replaced. New vent flashing should be installed to help prevent moisture from entering into the roof system. The inspector recommends correction by a qualified roofing contractor.

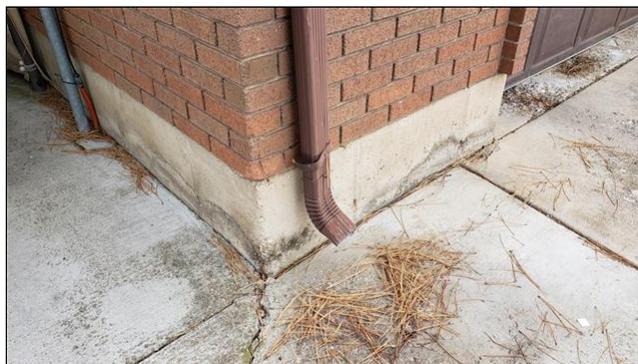
1.2 Item 2(Picture)

**Improve:** One or more downspouts on the exterior of the home are damaged and should be repaired or replaced to prevent possible failure and to allow for proper drainage away from the foundation.

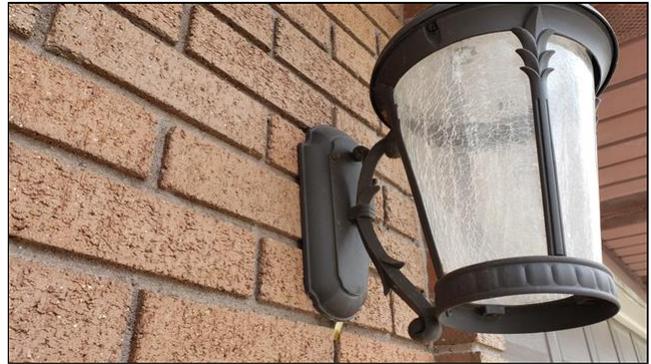
2.0 Item 3(Picture)

**Improve:** The areas around exterior light fixtures have not been sealed. Recommend caulking around fixtures with appropriate sealant to help prevent moisture intrusion in the wall assembly.

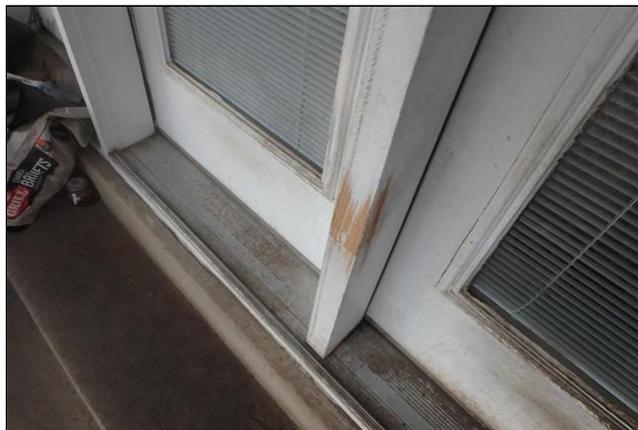
2.2 Item 2(Picture)

**Improve:** The back door has pet damage. The affected areas should be prepped and painted to improve durability and prolong the life of the door. Further deterioration may occur if not repaired.

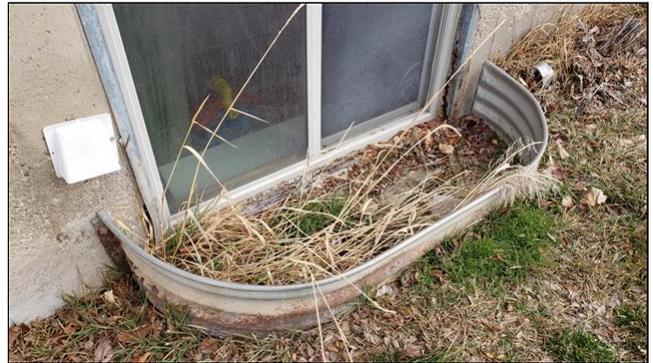
2.4 Item 2(Picture)

**Improve:** The window wells had accumulated debris; this can allow moisture intrusion into the basement. The window wells should be cleared to encourage proper drainage and minimize the retaining of moisture near the foundation and window.

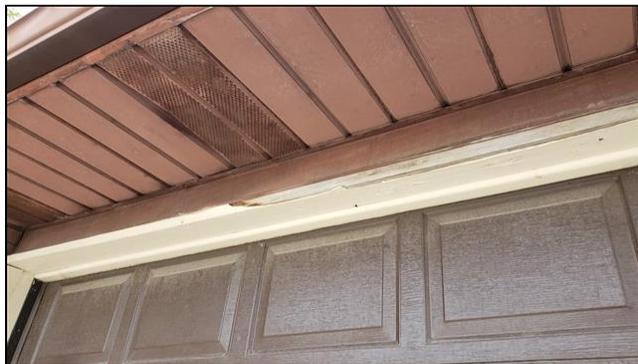
3.0 Item 1(Picture)

**Improve:** Wood trim around the garage door is weathered and should be prepped and painted to improve durability.

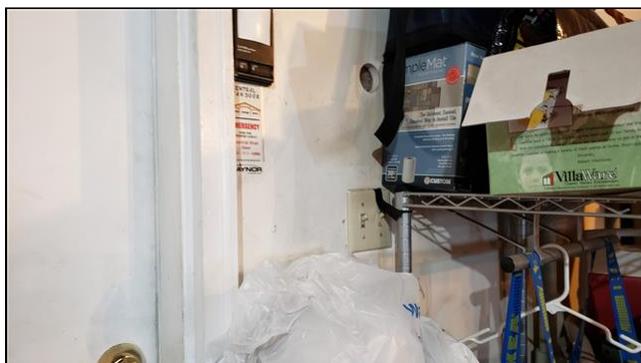
5.4 Item 1(Picture)

**FYI:** Inspector was unable to determine the function of one or more switches.

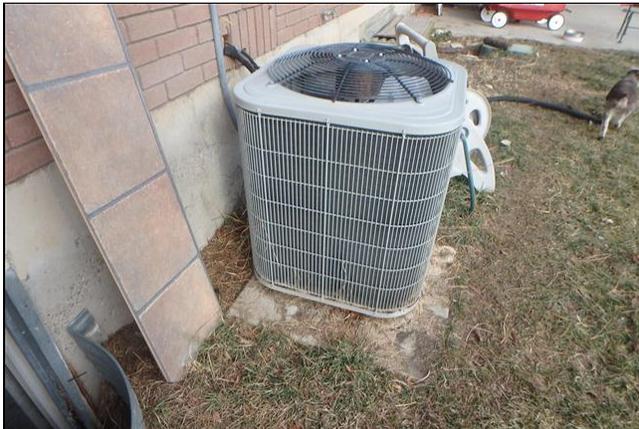
7.6 Item 1(Picture)

**Improve:** The pad supporting the air-conditioner compressor housing should be raised to 3 inches above grade. This can protect the unit from damage.

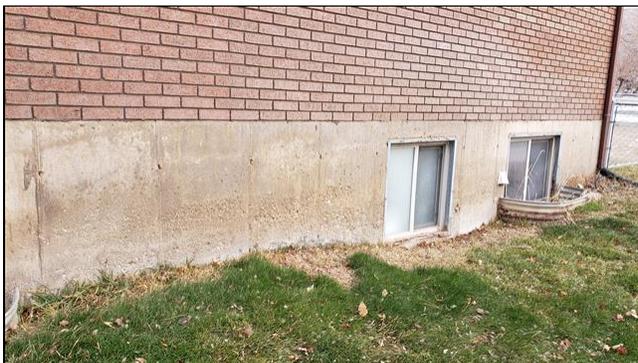
8.0 Item 1(Picture)

**Improve:** Minor deterioration was noted in the exterior foundation. It is recommended patching with an appropriate material to help prevent continued deterioration.

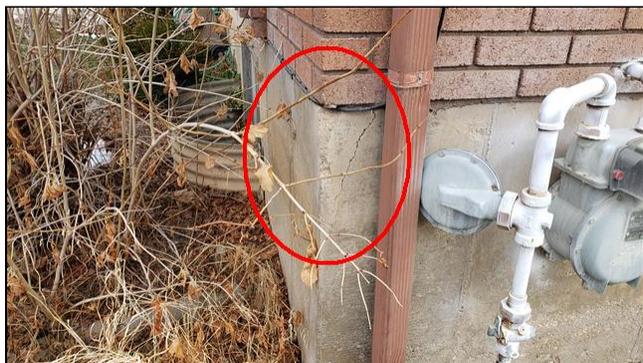
8.0 Item 3(Picture)

**Monitor:** One or more exterior corners of the concrete foundation wall was cracked or broken. Exterior corners are high-stress areas and this condition is not unusual in some homes. The foundation appeared to be adequately supporting the exterior wall structure in this area at the time of the inspection.

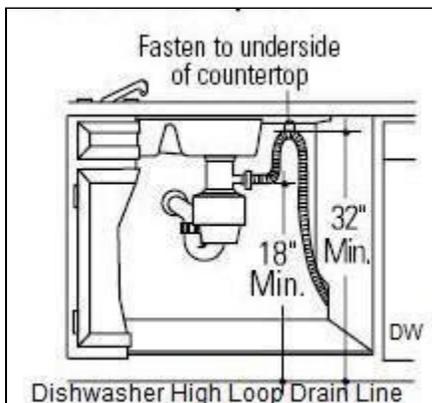
10.1 Item 1(Picture) High-loop

**Improve:** A high loop was not present for the dishwasher drain line. For proper operation, the dishwasher waste line should loop above the connection point below the kitchen sink. The high loop is designed to prevent wastewater from contaminating the dishwasher.

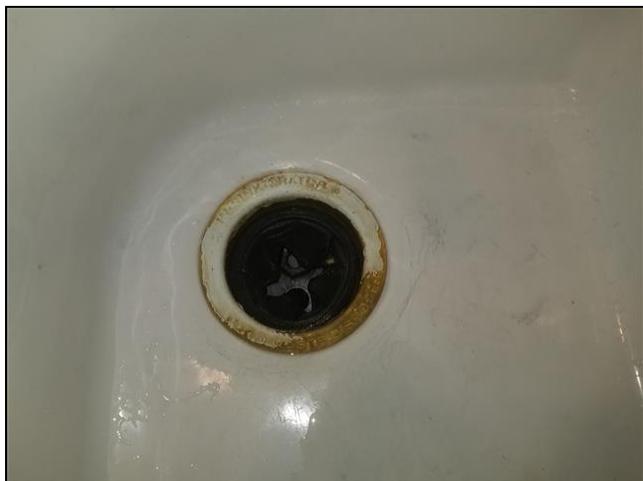
10.2 Item 1(Picture)

**Improve:** The splash guard for the waste disposer is damaged. A new splash guard should be installed to prevent injury from items ejected during disposal operation.
